U.S. Army
Coast. Eng. Res.
Ctr.
MP 10-75
(AD-A018 89

Beach Profile Changes : East Coast of Lake Michigan, 1970-72

by
R.A. Davis, W.G. Fingleton, and P.C. Pritchett

MISCELLANEOUS PAPER NO. 10-75
OCTOBER 1975

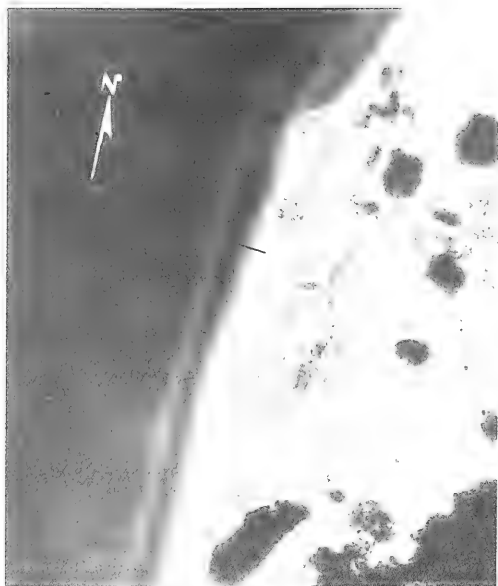
Figure 6. Location and geomorphology of profile site 1.

Geomorphology. Site is located at Point Betsie, Michigan, with a shore-line orientation of $N.13^{\circ}E$. Coast is comprised of generally stabilized dunes. Beach sediment is sand and gravel with the backshore mostly sand and the foreshore composed of coarse pebbles and cobbles which commonly display imbrication. Beach is one of the highest energy locations in the study area. Occasional gravel berms, and ridge and runnel features are present.

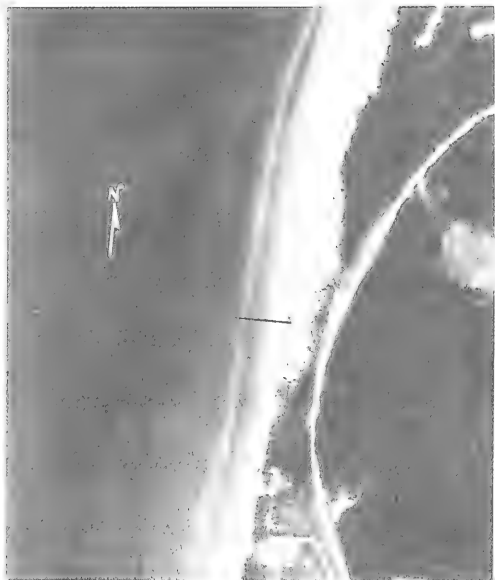
Figure 7. Location and geomorphology of profile site 2.

Geomorphology. Beach is located near the Benzie-Manistee County line. Shoreline orientation is N.05°E. and narrow beach is situated just below Inspiration Point. Bluff rises more than 250 feet above lake level and is composed of Pleistocene dunes overlying coastal sands and gravel. Slope is steep and unstable.

Bench Mark Location (3 August 1970)
 (SW₄, sec. 34, T.25 N., R.16 W.). At base of steep vegetated slope below scenic lookout, a few feet north of large poplar tree. Azimuths (from north): 269°33', large poplar tree; 359°26', Frankfort lighthouse on jetty; 1°30', middle trunk of three poplar trees.

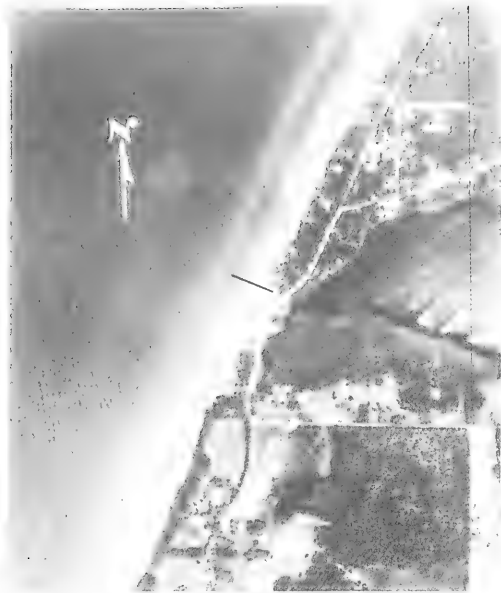
Figure 8. Location and geomorphology of profile site 3.

Geomorphology. Site is adjacent to Bar Lake in Manistee County. Shoreline orientation is $N.27^{\circ}E$. Beach is bounded by a terrace of beach and dune sands that rises 10 to 20 feet above the lake. Sediment is mostly sand. Scattered fine gravel sometimes is present in the plunge zone only.

Bench Mark Location (3 August 1970)
 (SE $\frac{1}{4}$, sec. 24, T.22 N., R.17 W.).
 On Crescent Beach Road north of Manistee, about 100 feet north of public access beach. Azimuths (from north): $6^{\circ}10'$, east margin of larger of two islands; $20^{\circ}40'$, corner of house (105'); $41^{\circ}54'$, corner of house.

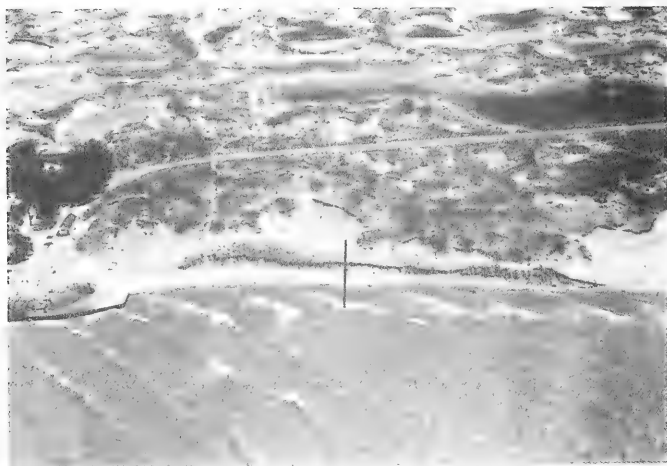
Figure 9. Location and geomorphology of profile site 4.

Geomorphology. Beach at Big Sable Point has a shoreline orientation of $N.7^{\circ}E$. This part of the eastern Lake Michigan coast is one of the most extensive dune areas. Dunes extend several miles in either direction from Big Sable Point and a few miles inland at the point. Dunes are covered with grass and small bushes. Virtually no gravel was found, reflecting the proximity to dunes.

Bench Mark Location (3 August 1970)
 ($SW\frac{1}{4}$, $NW\frac{1}{4}$, sec. 7, T.19 N., R.18 W.). About 300 yards, south of lighthouse at Big Sable Point, in front of blowout. Azimuths (from north): $7^{\circ}48'$, lighthouse spire; $344^{\circ}50'$, western margin of seawall; $358^{\circ}12'$, U.S. Coast Guard flagpole. Bench mark was moved 15 feet landward 7 April 1972, and 50 feet landward 4 June 1972.

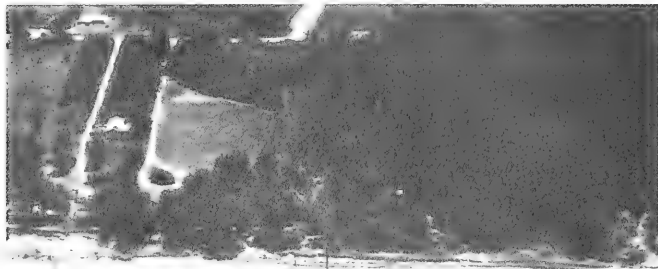
Figure 10. Location and geomorphology of profile site 5.

Geomorphology. Beach at Summit Township Park (Mason County) has a shoreline orientation of N.7°W. and is adjacent to bluffs of glacial drift. At times, glacial till was observed cropping out just lakeward of the plunge step. Foreshore comprised of well-sorted and rounded cobbles. Large percentage of the sand in backshore is from a sand terrace where the upper swash of waves has undercut the terrace and vertical slope has failed.

Bench Mark Location (3 August 1970)
 (NW¼, sec. 23, T.17 N., R.18 W.).
 Immediately fronting large, dead maple tree, just south of Summit Park. Azimuths (from north): 83°04', north of maple tree; 201°15', Little Sable Point; 343°19', end of groin; 351°39', large stump west edge.

Nearly all of the terrace erosion at this site (Fig. 10) was during a 2-month period in the fall of 1970. Similar erosion did not take place at either of the adjacent sites during that period. Steep bluffs just to the north of the site were severely eroded throughout most of the study period. This site and site 10 with a similar shoreline orientation, were the only sites subjected to significant erosion during October and November 1970. This suggests a single storm was probably responsible for the erosion and had little effect at the other sites because of their different orientation to the wave approach.

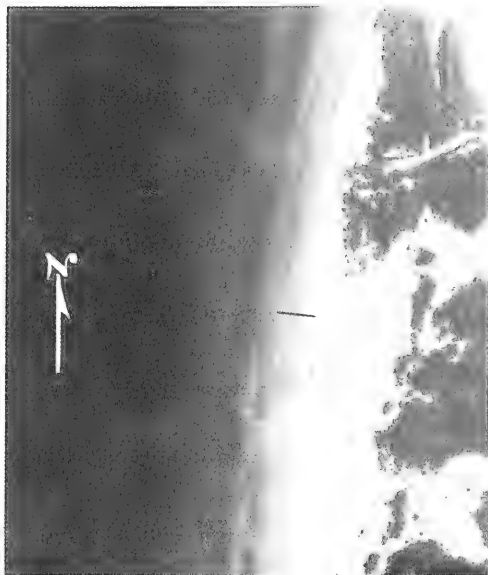
Figure 11. Location and geomorphology of profile site 6.

Geomorphology. Shoreline orientation at Little Sable Point is $N.7^{\circ}E$; beach is just south of large, active dunes near Silver Lake. Immediately adjacent are moderately active small grass-covered dunes. Beach and immediate nearshore composed of sorted, medium sand throughout the year. During the winter this was the only location that did not have a snow cover on the beach at any time, reflecting the significance of wind activity in this general area.

Bench Mark Location (3 August 1970)
 ($NE\frac{1}{4}$, $SE\frac{1}{4}$, sec. 35, T.15 N., R.19 W.).
 Public access area about 200 yards north of lighthouse at Little Sable Point. Grassy dune 60 to 65 feet north of path. Azimuths (from north): $164^{\circ}26'$, westernmost of group of three poplar trees (120'); $173^{\circ}12'$, lighthouse spire; $357^{\circ}06'$, west side of private beach sign.

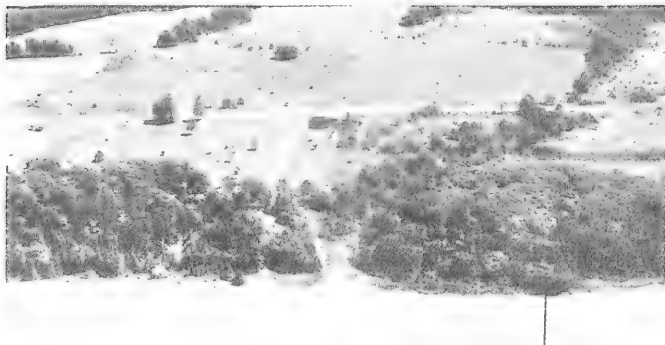
Figure 12. Location and geomorphology of profile site 7.

Geomorphology. Shoreline at Claybanks Township Park in Oceana County trends N.18°W. This is one of the most extensive regions of glacial till bluffs along the eastern shore of Lake Michigan. At the base of the bluffs is a narrow terrace of sand which contains a small eolian ridge.

Bench Mark Location (3 August 1970)
(NW¼, sec. 17, T.13 N., R.18 W.). About 100 yards south of southern path to beach at Claybanks Park. On grassy bank in front of steep till bluffs. Azimuths (from north): 162°30', point of land south toward Montague; 325°02', outermost of old piling in surf.

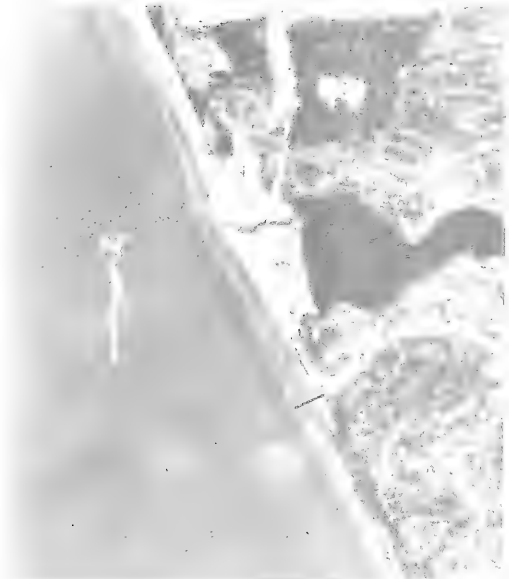
Figure 13. Location and geomorphology of profile site 8.

Geomorphology. Dunes and Pleistocene lake sands characterize the beach. Shoreline orientation is N.24°W. Location is just south of a paved highway between Lake Michigan and Duck Lake. Recent erosion has endangered the highway and large concrete slabs have been dumped along the beach where the highway is close to the lake. Net littoral drift is to the south so that the site is in the lee of the protected beach and is deprived of sediment transported downdrift.

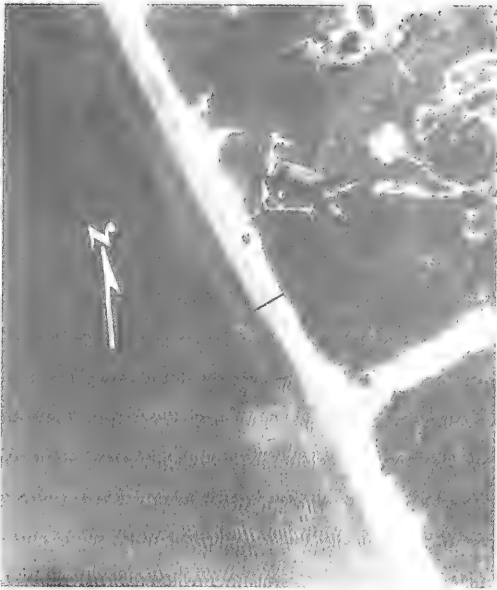
Figure 14. Location and geomorphology of profile site 9.

Bench Mark Location (3 August 1970)
 SW¼, sec. 25, T.9 N., R.17 W.). At P.J. Hoffmaster State Park on Lake Harbor Road south of Muskegon. About 300 yards south of beach access and 130 feet north of *Patrolled Beach* sign. Halfway between two large pine trees. Azimuths (from north): 165°40', power company smokestack; 167°00', west edge of red house on Grand Haven jetty; 331°04', red light tower, Muskegon jetty.

This site (Fig. 14) experienced moderate terrace erosion during the study period, receding 6 feet the spring of 1971 and 3 feet the following fall (Table 4). Other than site 7, this was the only site to experience more than 1 foot of recession during the spring of 1971. A possible reason for the recession was the narrow width of the beach which permitted a direct attack of low-intensity spring storms on the foredune terrace.

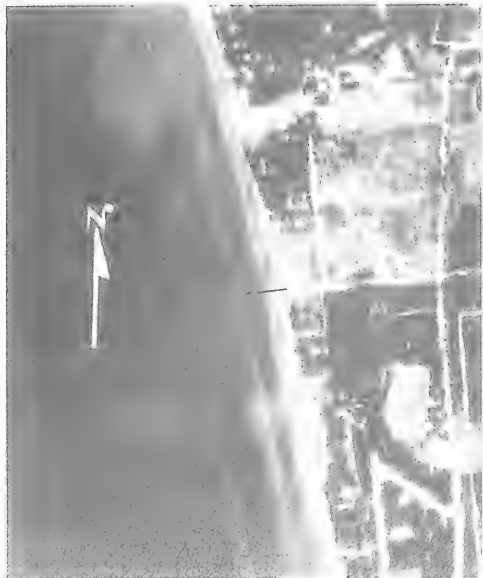
Figure 15. Location and geomorphology of profile site 10.

Geomorphology. The public access beach at Buchanan Street (Ottawa County) has a shoreline orientation of $N.11^{\circ}W.$ and is located along a coast composed of small dunes covered with mature trees. These dunes extend to the active beach. Subsequent erosion has cut back to a till layer which rises about 8 feet above the lake and is capped by sand dunes

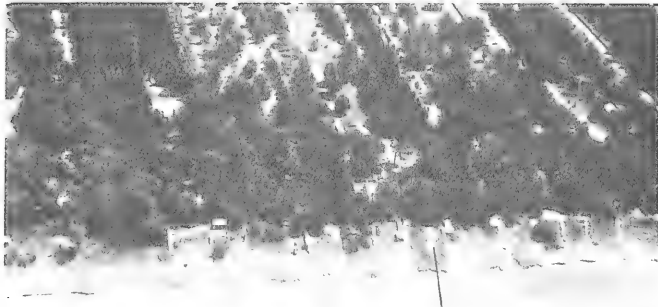
Figure 16. Location and geomorphology of profile site 11.

Bench Mark Location (3 August 1970)
 (NW $\frac{1}{4}$, sec. 21, T.5 N., R.16 W.).
 In front of DeLeeuw residence, 396 north Lakeshore Drive, Holland; about $\frac{1}{4}$ -mile south of Park Township Public Beach. Azimuths (from north):
 $183^{\circ}33'$, red lighthouse, Holland;
 $187^{\circ}45'$, end of jetty, Holland;
 $357^{\circ}18'$, end of jetty, Port Sheldon.

The profile at site 11 (Fig. 16) remained stable throughout the first year of study and experienced only 4 feet of erosion during the fall storm period in the second year (Table 1). Closely spaced survey data are available from a time-series study conducted at this location during the summer of 1970 (Fox and Davis, 1971a, b; Davis and Fox, 1971).

At this site there are fetches of between 80 to 180 miles in directions from which strong winds are frequent (Fig. 2). These winds could produce waves large enough to cause modest recession rates. The terrace recession in late fall of 1971 was during the period of normal high energy. Site 12 to the south also showed significant erosion during the same period, suggesting a regional effect of storm activity. These two sites are the only adjacent locations that experienced "simultaneous" erosion during the entire 2-year period.

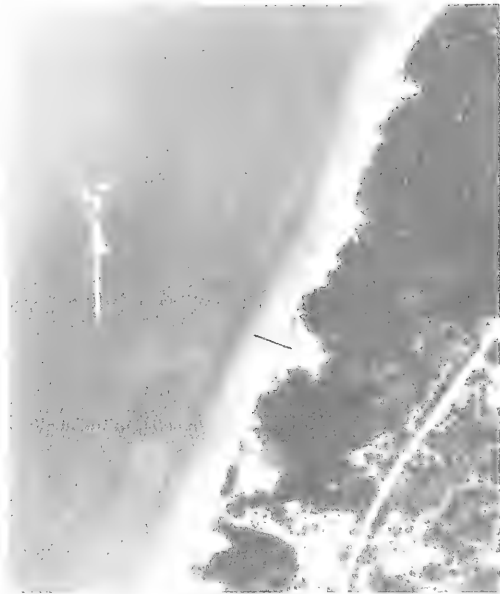
Figure 19. Location and geomorphology of profile site 14.

Geomorphology. The Van Buren State Park site is located at the base of a large blowout in vegetated dunes that rise about 150 feet above lake level and are among the largest along the eastern Lake Michigan coast. Shoreline orientation is N.25°E. Top of a thick Pleistocene peat bed, exposed in a steeply inclined terrace at the upper margin of the beach, has been dated at 4,000 B.P. (Zumberge and Potzer, 1956). During a 1969 summer storm, glacial till was exposed in the nearshore zone just lakeward of the plunge step; not known to be exposed during the present study.

Terrace erosion was completely stable at this site (Fig. 19) during the 2-year study period. This location, also monitored since June 1968, showed considerable erosion during 1968-70. More than 25 feet of beach eroded in late fall of 1968 and a small amount occurred during an unusually severe summer storm in 1969 (Fox and Davis, 1970b). Although the beach has exhibited changes, no erosion to the foredune area has occurred since 1969.

Beach width varies considerably but there is a general abundance of beach sediment as evidenced by the frequent presence of ridge and runnel topography. This protects the dunes from any direct wave attack and stabilizes the terrace. Although the study site remained stable, severe erosion was noted only a few hundred yards in either direction of the location.

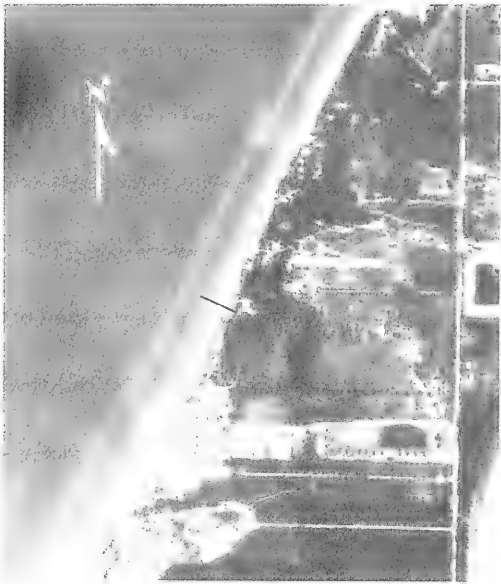
Figure 21. Location and geomorphology of profile site 16.

Geomorphology. Beach at Stevensville, Michigan, has a shoreline orientation of $N.28^{\circ}E.$ and is the site of the time-series study by Fox and Davis (1970a, b). Fore-dune terrace is adjacent to small vegetated dunes. One mile or more to the north (updrift) is an extensive stretch of high bluffs of glacial till.

This site (Fig. 21) was also stable with the exception of a few feet of erosion during the first study year. The bluff receded 4 feet in the late fall of 1970 and 1 foot the following spring. No erosion occurred during the second year. This site was investigated in great detail during a time-series study in the summer of 1969 (Fox and Davis, 1970a). Most of the bluff erosion took place during a severe summer storm (Fox and Davis, 1970b) and the fall storm period. Total recession during the last half of 1969 was 25 feet. Stability has prevailed since that time, however, despite the high energy conditions that occurred in the fall of 1970 and 1971. Erosion was pronounced in adjacent areas during both years.

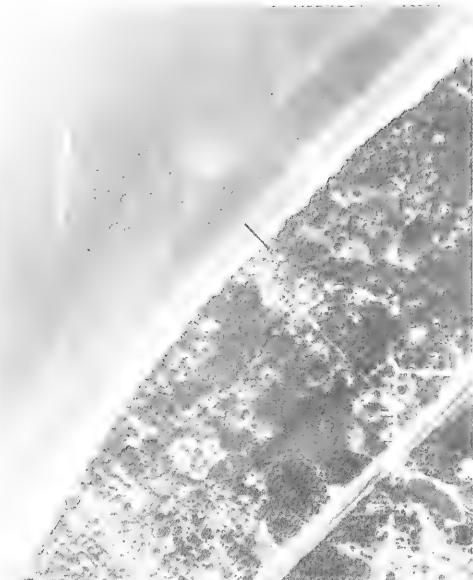
Geomorphology. Site located at Chickaming Township Beach, Lakeside, Michigan, has a shoreline orientation of N.43°E. Coastal area is dominated by stabilized dunes and bluffs of glacial till. Till is exposed on a bluff just to the north and behind the site. In an earlier study (Davis, 1964) glacial till was exposed in the inner nearshore area, but was not observed during this study. Sand terrace is present in most of the area.

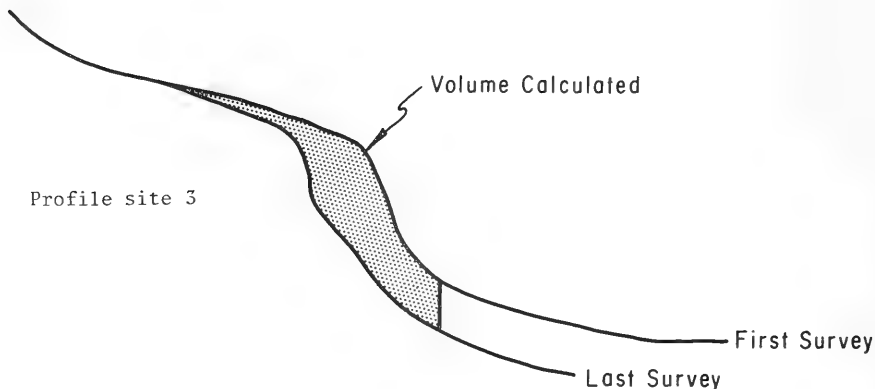
Figure 25. Example of eroded volume computation.

The volume of material removed from the dunes or bluffs was estimated during each year of the 2-year study. These values were computed by overlaying the first and last surveys for a study year, locating the intersection of the beach with the bluff on the first survey, dropping a vertical line from that intersection to the profile of the last survey, and then calculating the volume eroded landward of that vertical line. The resulting volume is shown two-dimensionally in Figure 25. The composition of the bluff (sand or till) and the volume eroded for each year are shown in Table 6. The pattern of erosion is presented in Section V, Profile Descriptions; volumes calculated range from 0 to 19.9 cubic yards per foot of beach front per year. Data on the size distribution of eroded material were not collected.

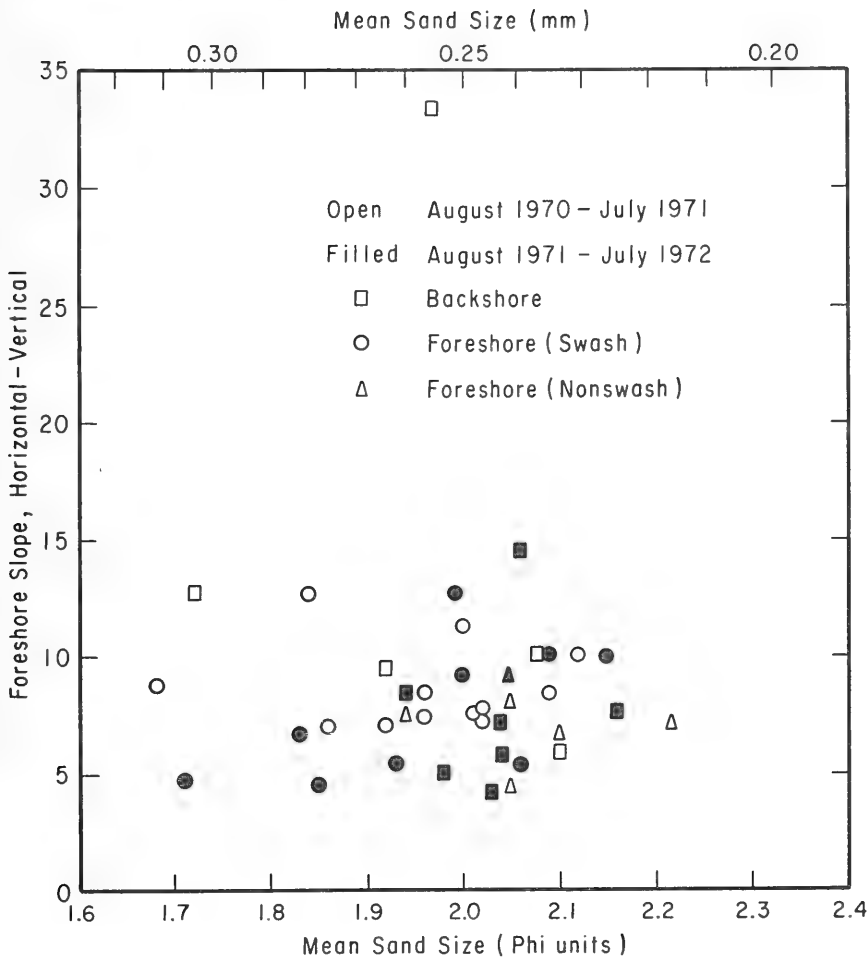
Figure 26. Foreshore slope versus mean sand size at profile site 10.

No textural patterns in the beach sediment samples prevail along a major part of the study area, although each location is characterized by a particular sediment type which is retained throughout seasonal changes. In previous investigations of ocean beaches (Bascom, 1951; Shepard, 1963) it was found that the slope of the foreshore was directly related to the mean grain size and inversely proportional to wave height. However, Great Lakes data show no trend, only a wide scatter of points (Hulsey, 1962; Coleman, 1969). The center of these points is consistent with the tendency of steeper slopes occurring with lower wave climate.

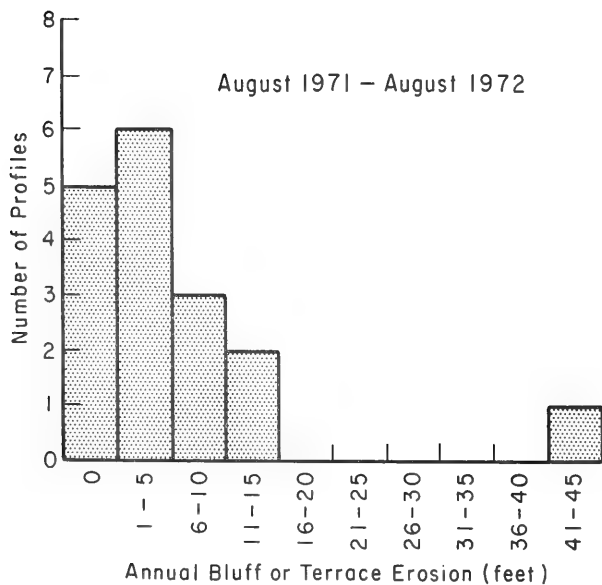
Figure 28. Distribution of yearly erosion.
